**2009 Annual Inspection Report**

**LITTLE LAKE SHORELINE  
PROTECTION / DEDICATED  
DREDGING NEAR ROUND LAKE  
(BA-37)**

State Project Number BA-37  
Priority Project List 11

July 2009  
Terrebonne Parish

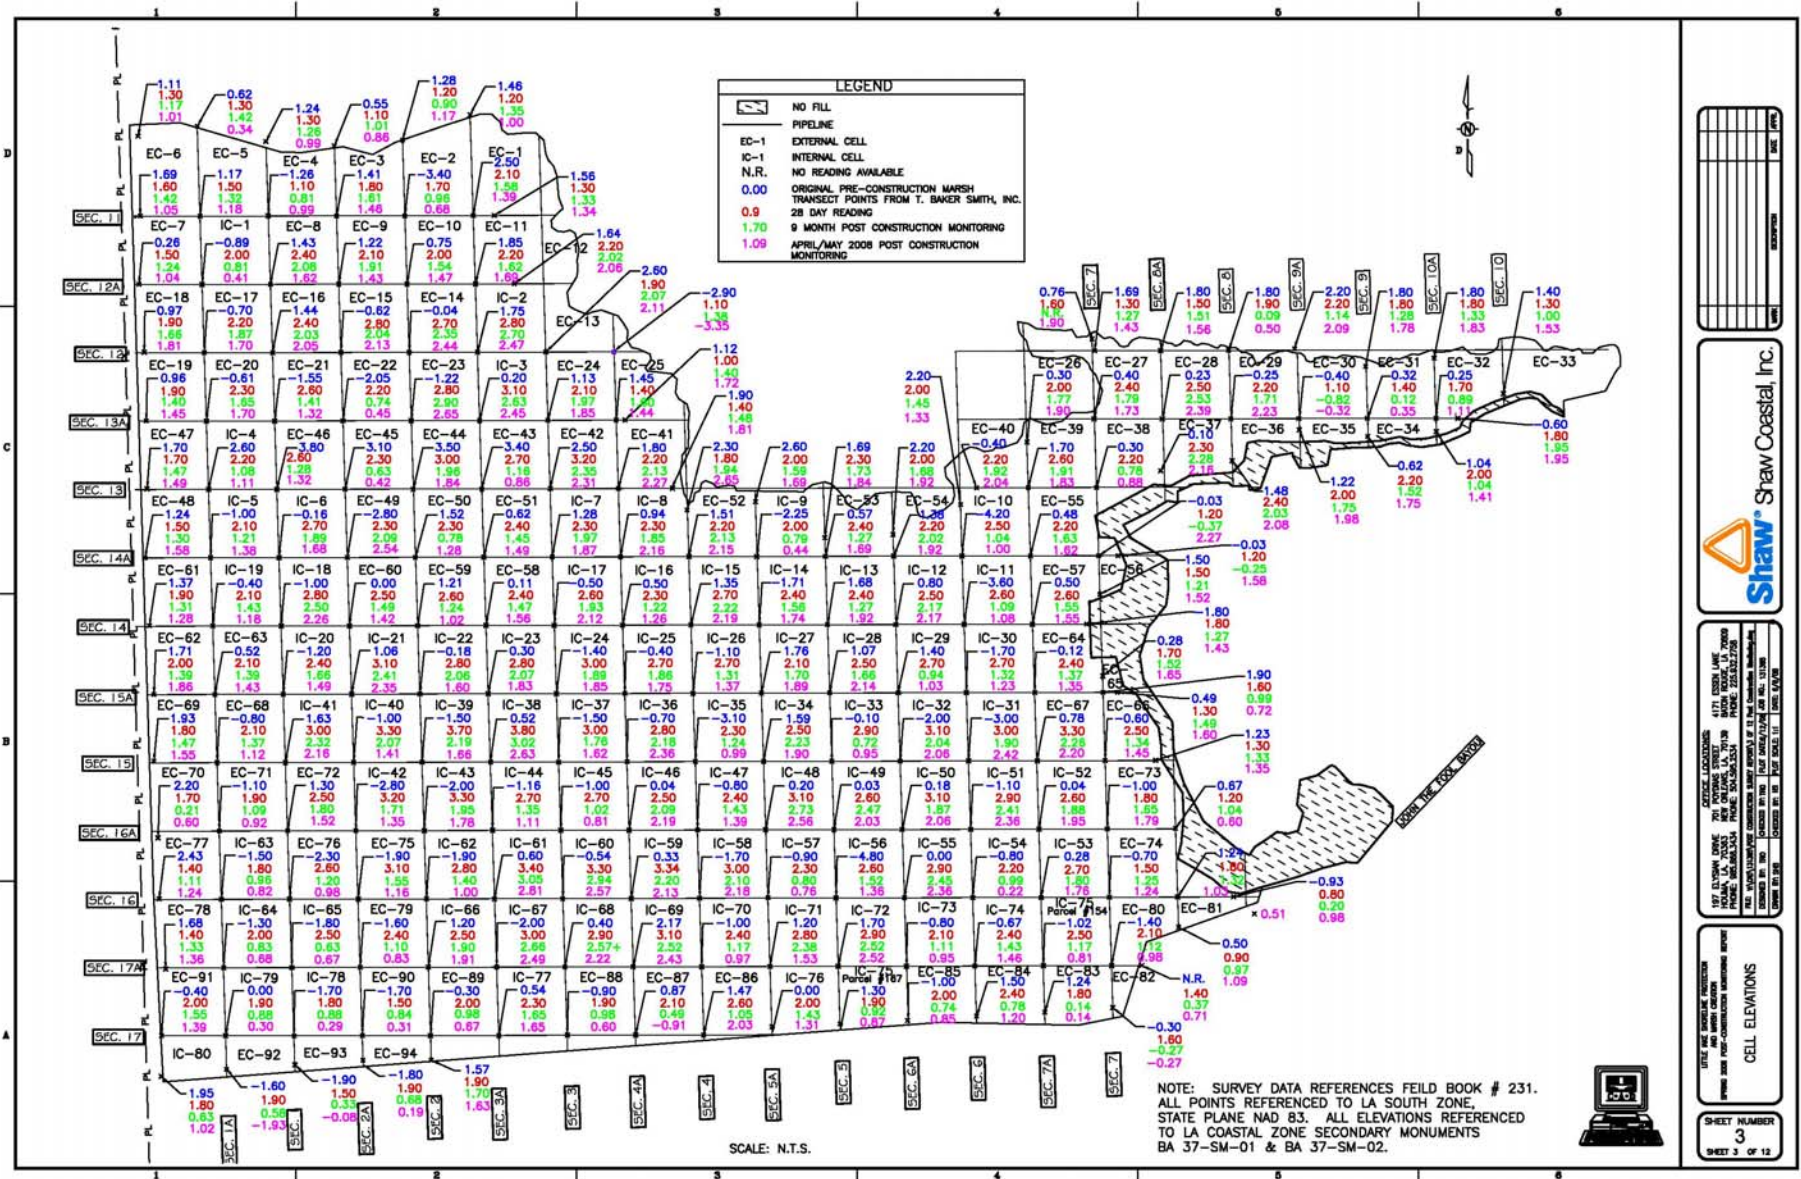
Figure 2. Marsh Creation Area Grid Survey showing Pre-Construction, As-Built (May-Aug 2006), May 2007, and May 2008 Elevations

The fill material in the marsh creation area has fully vegetated. As mentioned above, a survey was performed in May 2008 of the marsh creation area grid points. A map showing the elevations for the “as-built”, 9 month post-construction (May 2007), and May 2008 surveys of the marsh creation area is shown in Figure 2. The average grid elevations for the marsh creation area surveys are shown below.

Survey	Average Grid Elevation (FT, NAVD88)
As-Built (May-Aug 2006)	2.2
Post-Construction (May 2007)	1.49
Post-Construction (May 2008)	1.40

The marsh creation area appears to be completely vegetated. Surveys indicate the elevations are approaching average marsh elevation for the area. No maintenance funds have been provided for the marsh creation portion of the project other than surveying of the marsh creation area grid points. The surveys will continue to be performed annually for the first five years in order to monitor the consolidation and settlement of the fill material and the resulting elevations within the marsh creation area.

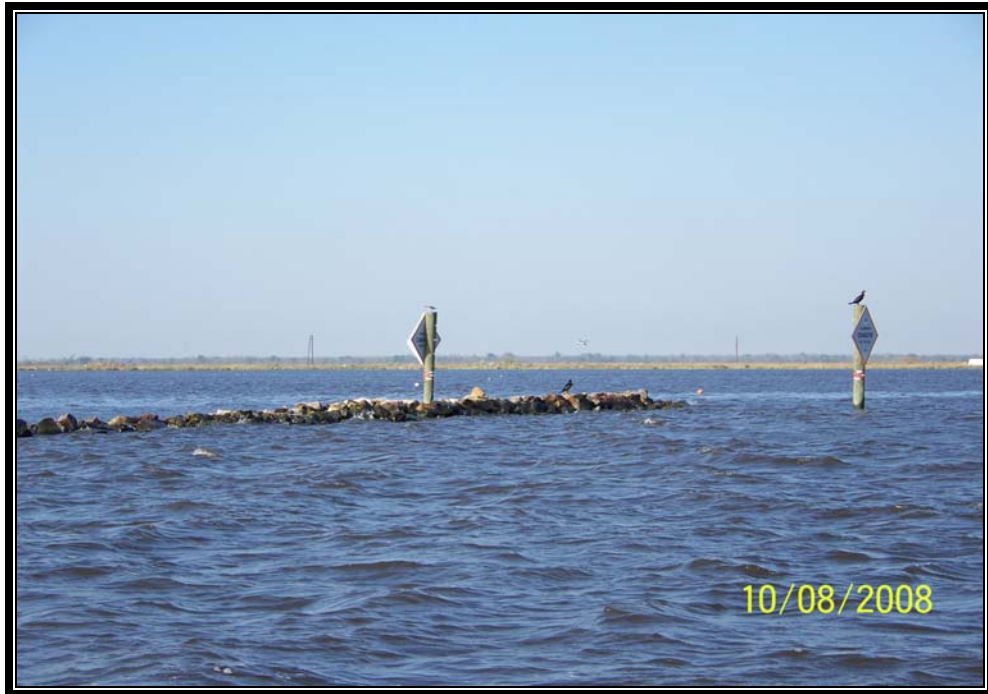
Photo 1 (0674) - Rock Segment 1. Tide Reading ~ 2.5 ft NAVD88

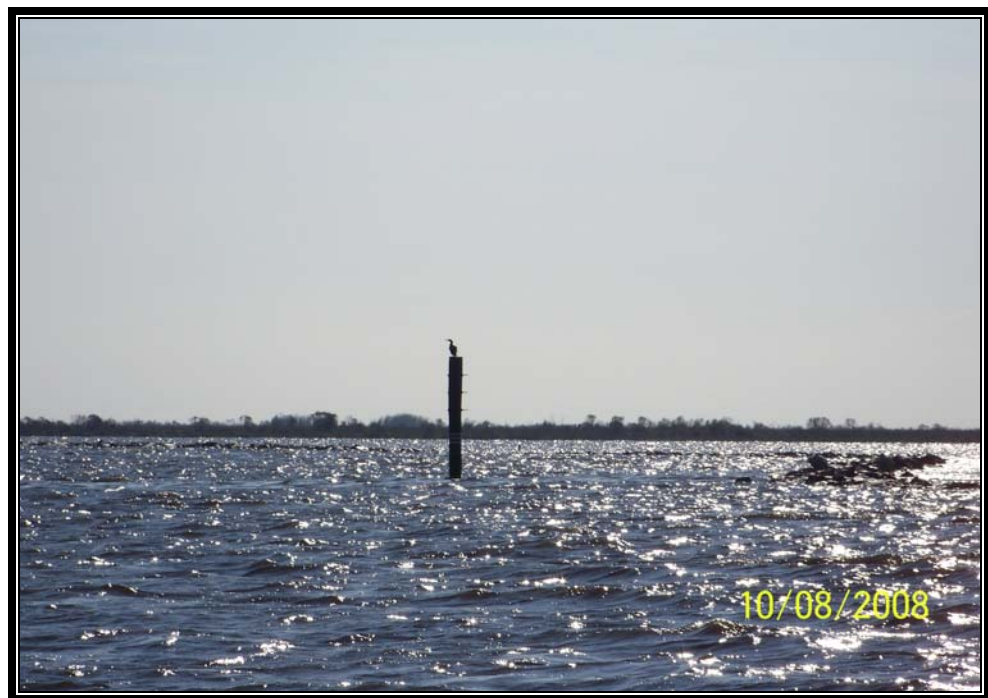
Photo 2 (0675) - Rock Segment 2. Tide Reading ~ 2.5 ft NAVD88

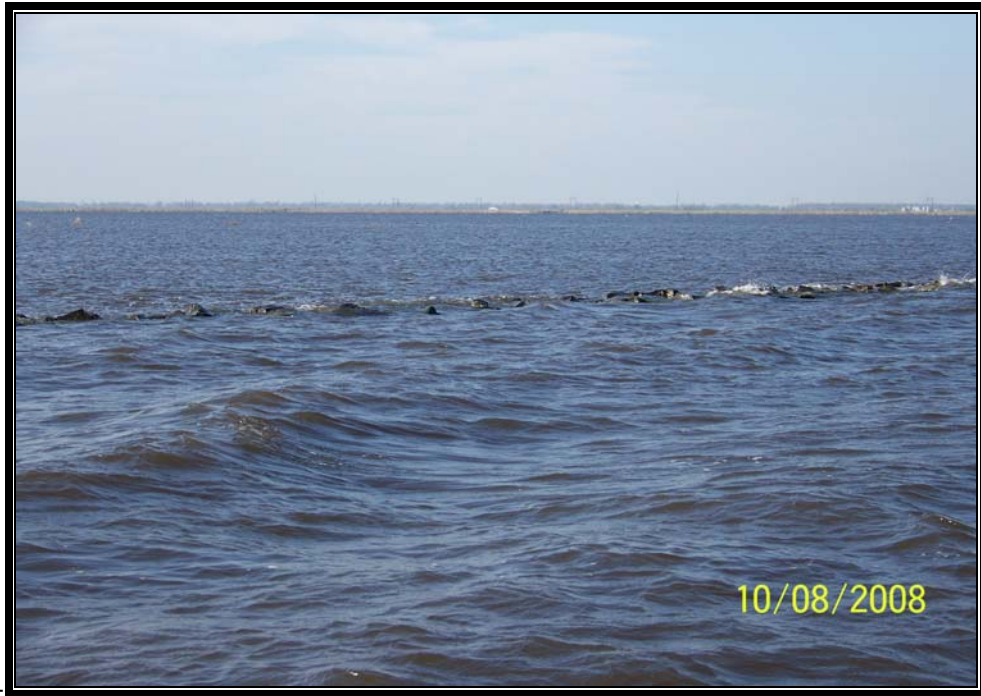
Photo 3 (0676) - Rock Segment 3. Tide Reading ~ 2.5 ft NAVD88

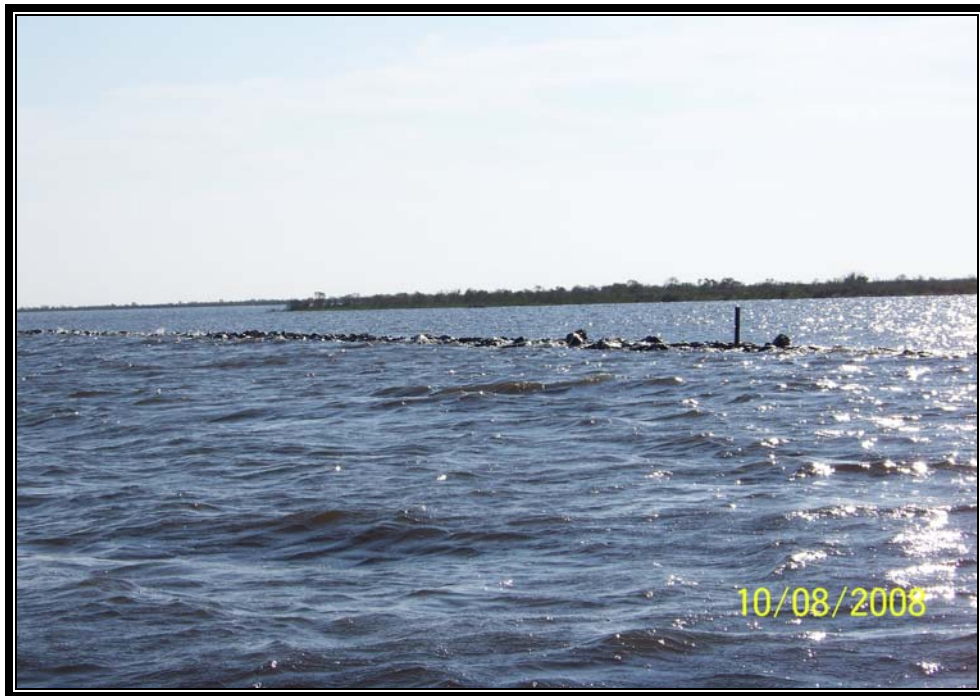
Photo 4 (0677) - Rock Segment 3. Tide Reading ~ 2.5 ft NAVD88

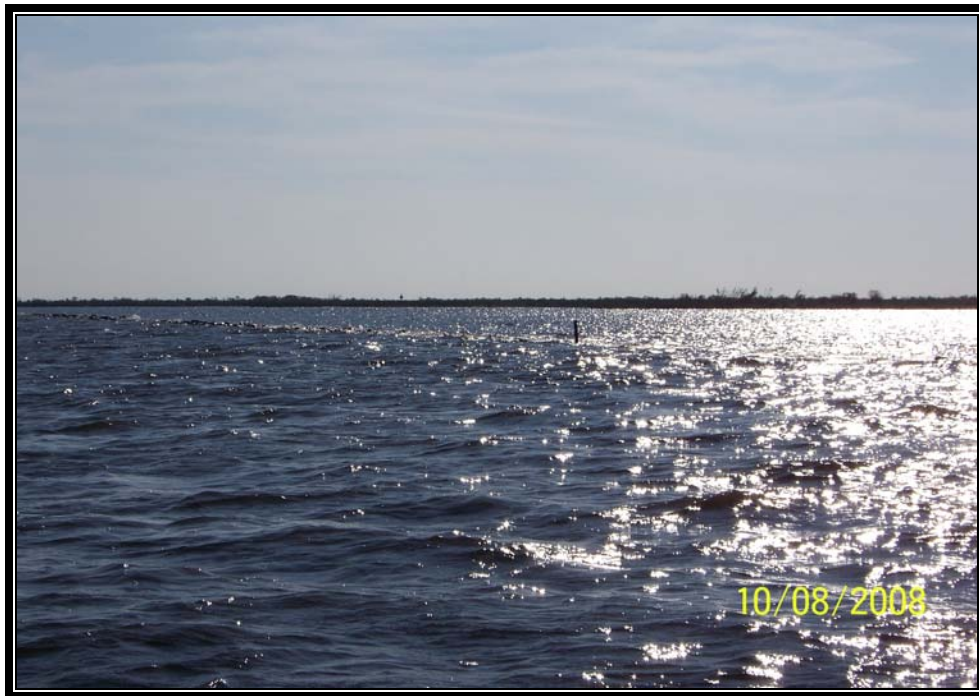
Photo 5 (0679) - Rock Segment 4. Tide Reading ~ 2.5 ft NAVD88

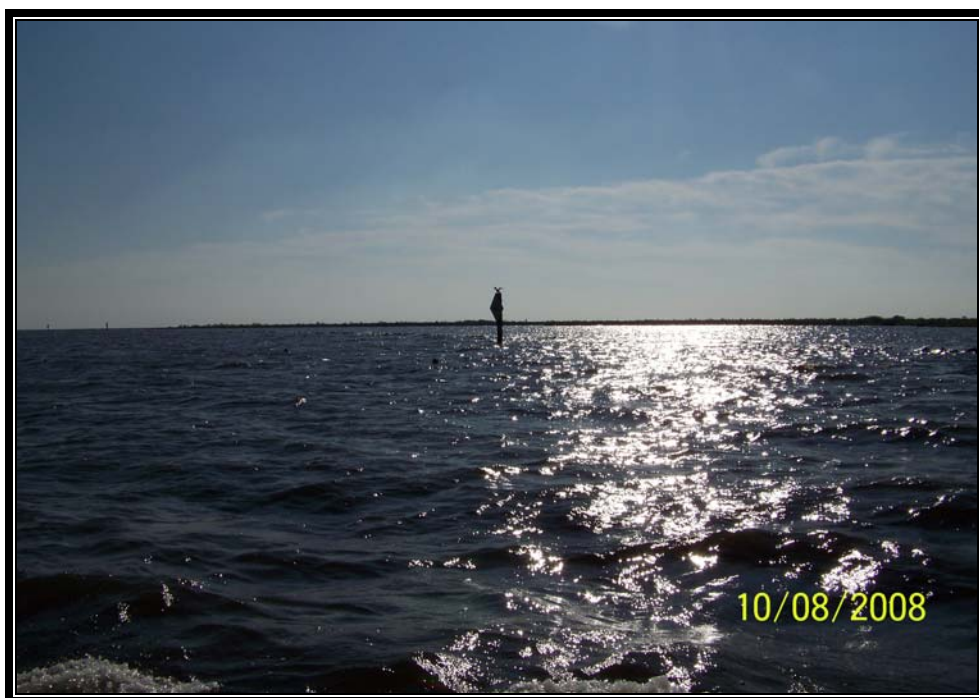
Photo 6 (0680) - Rock Segments 4 and 5. Tide Reading ~ 2.5 ft NAVD88

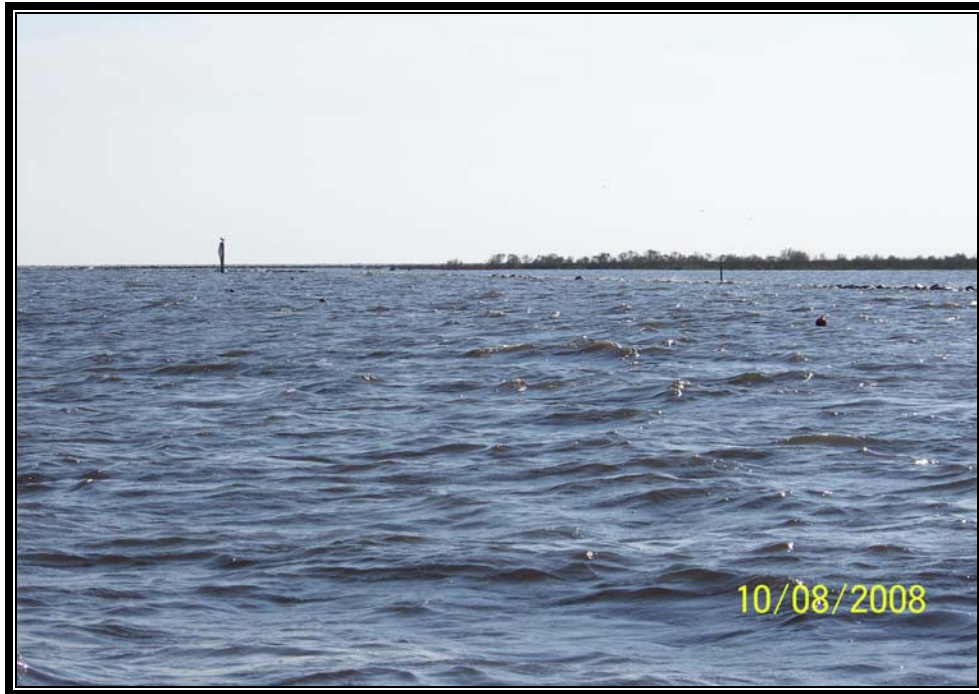
Photo 7 (0681) - Rock Segments 5 and 6. Tide Reading ~ 2.5 ft NAVD88

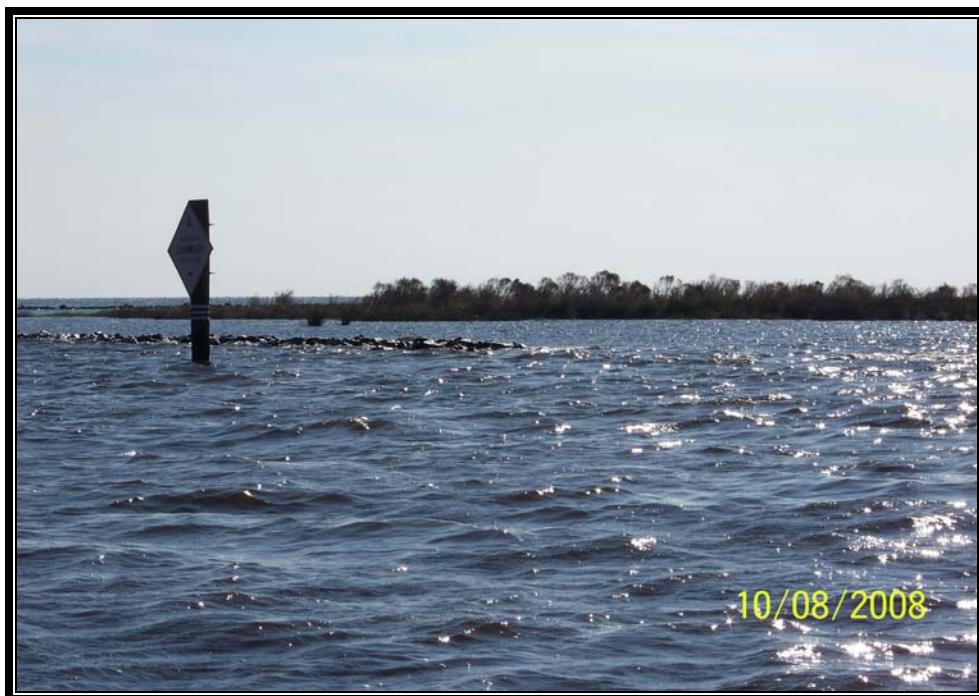
Photo 8 (0682) - Rock Segment 6. Tide Reading ~ 2.5 ft NAVD88

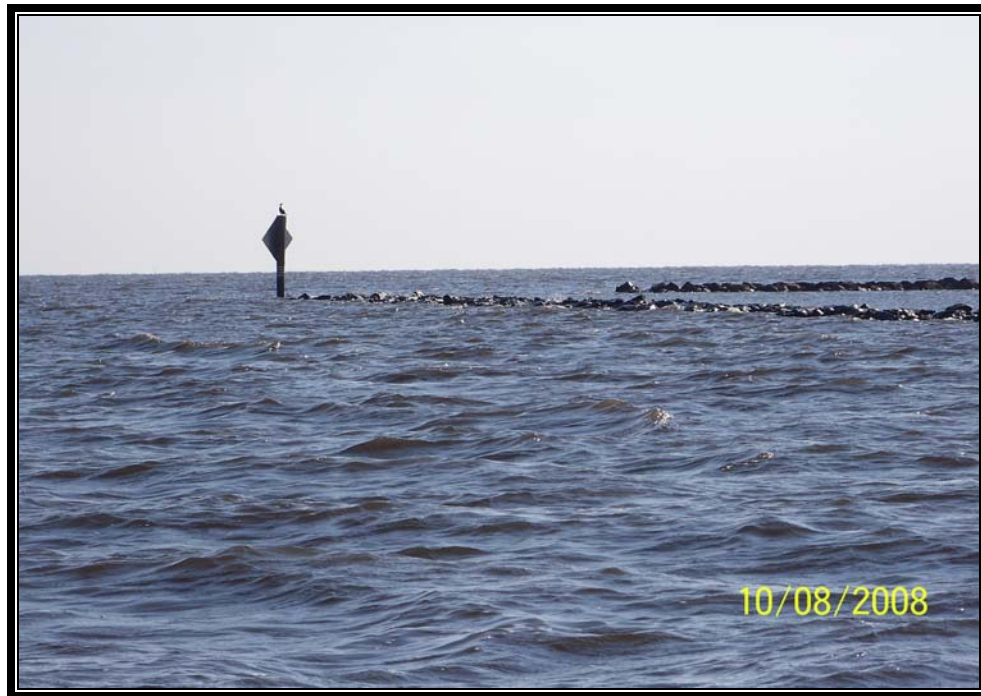
Photo 9 (0683) - Rock Segments 6 and 7. Tide Reading ~ 2.5 ft NAVD88

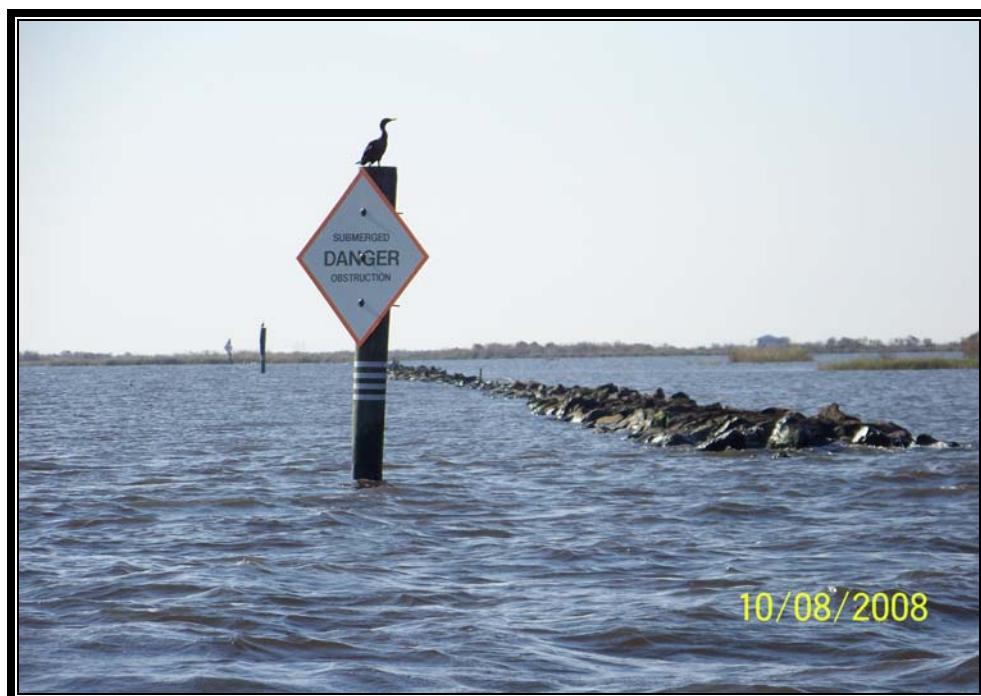
Photo 10 (0684) - Rock Segment 7. Tide Reading ~ 2.5 ft NAVD88

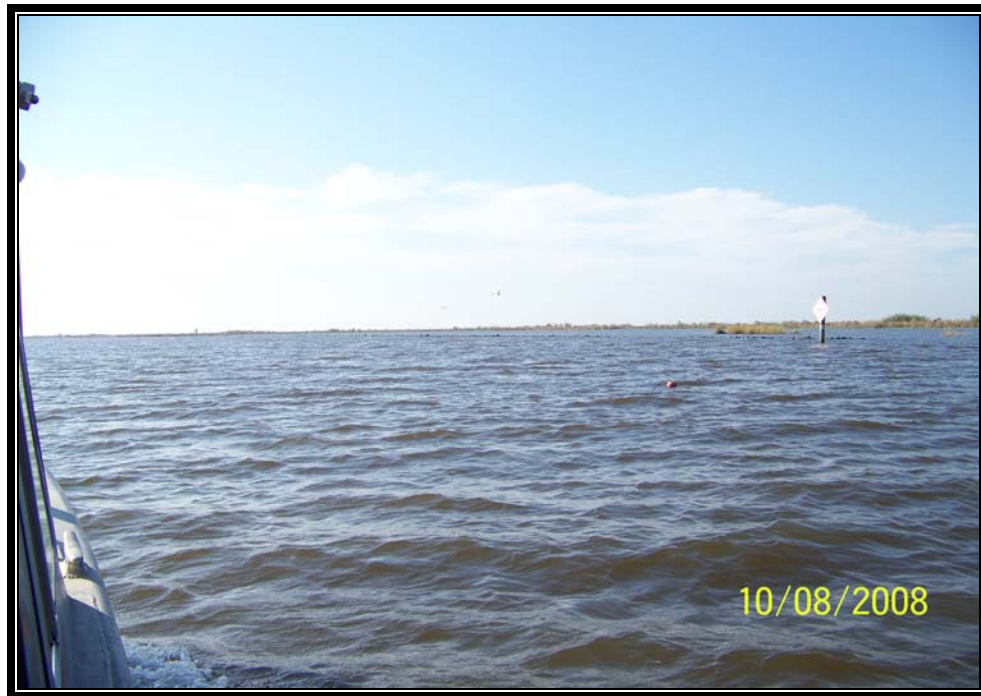
Photo 11 (0685) - Rock Segment 8. Tide Reading ~ 2.5 ft NAVD88

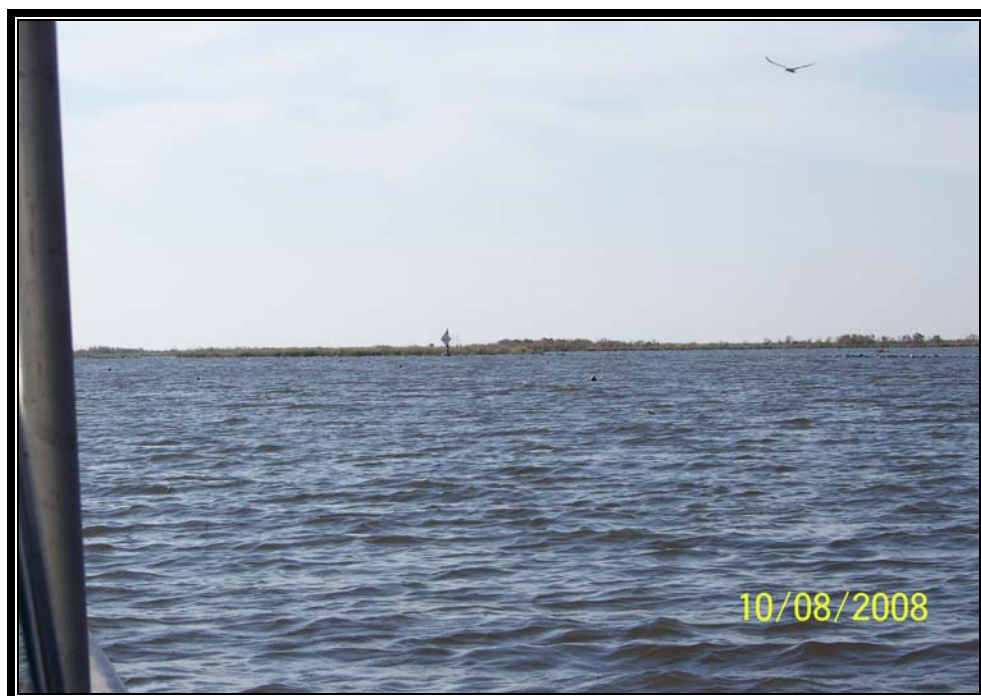
Photo 12 (0686) - Rock Segments 8 and 9. Tide Reading ~ 2.5 ft NAVD88

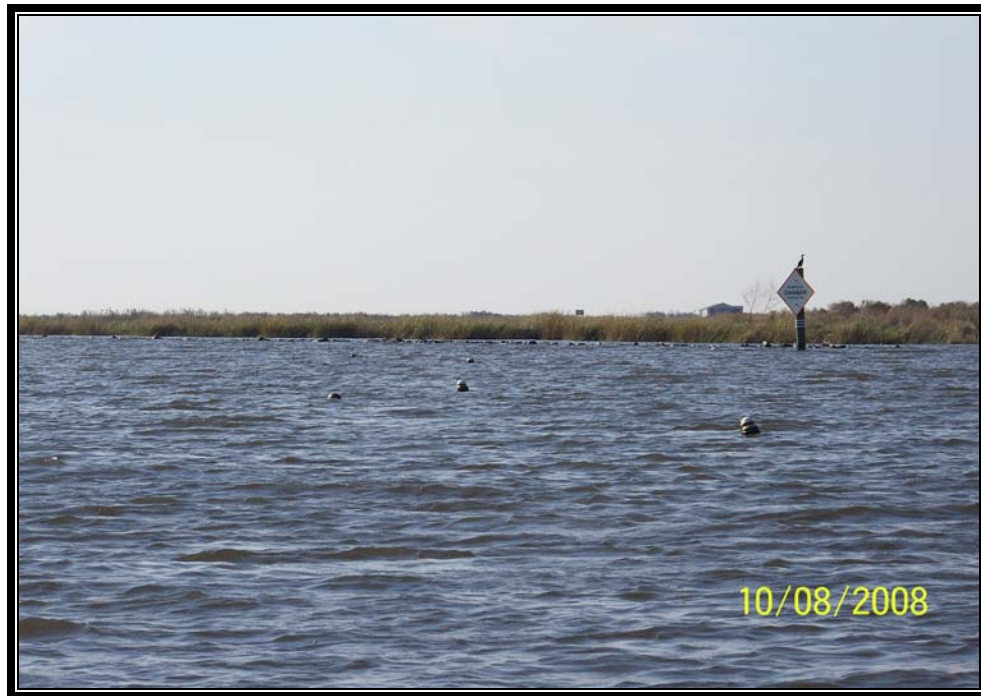
Photo 13 (0687) - Rock Segment 9. Tide Reading ~ 2.5 ft NAVD88

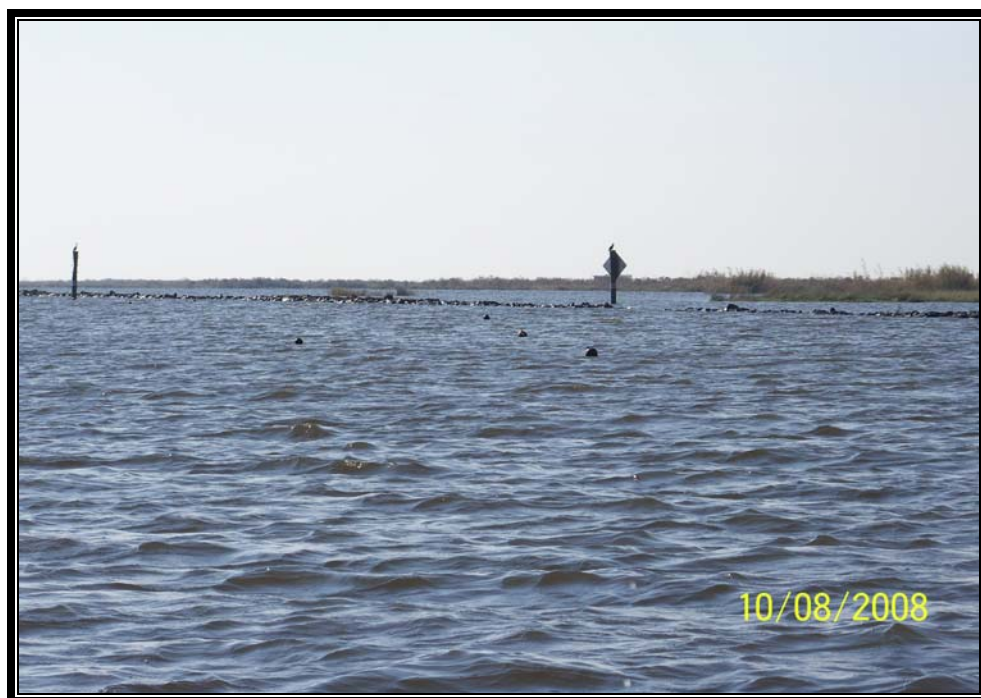
Photo 14 (0688) - Rock Segment 9. Tide Reading ~ 2.5 ft NAVD88

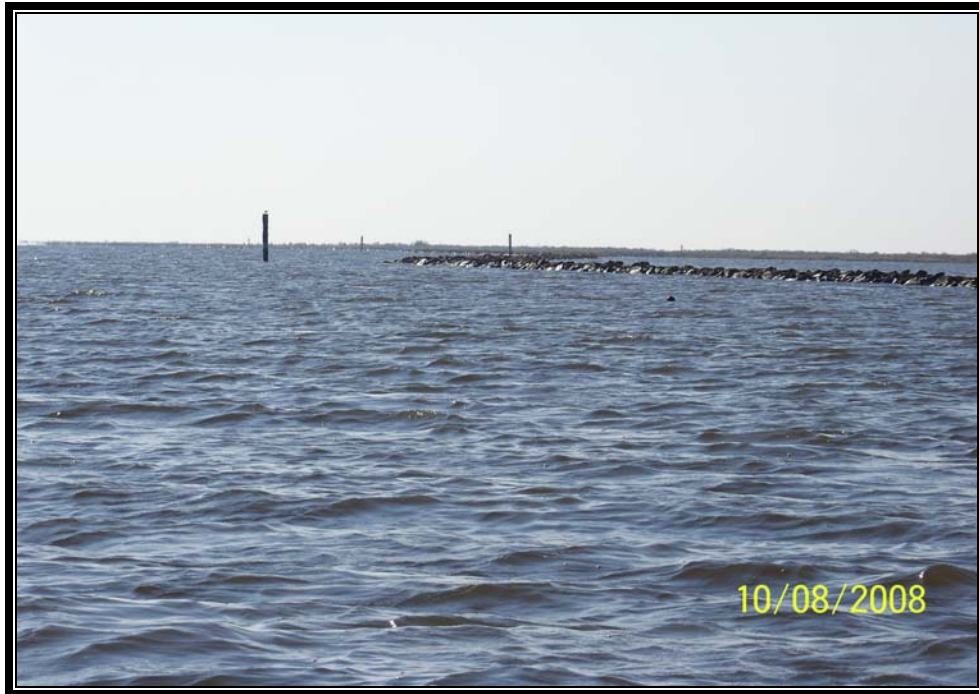
Photo 15 (0689) - Rock Segment 10. Tide Reading ~ 2.5 ft NAVD88

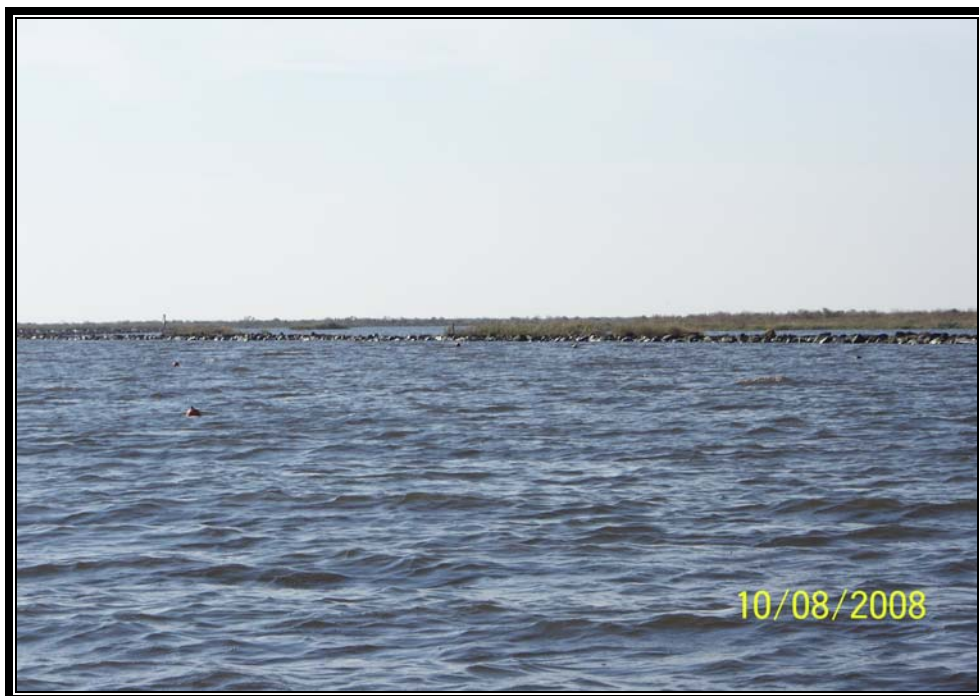
Photo 16 (0690) - Rock Segment 12. Tide Reading ~ 2.5 ft NAVD88

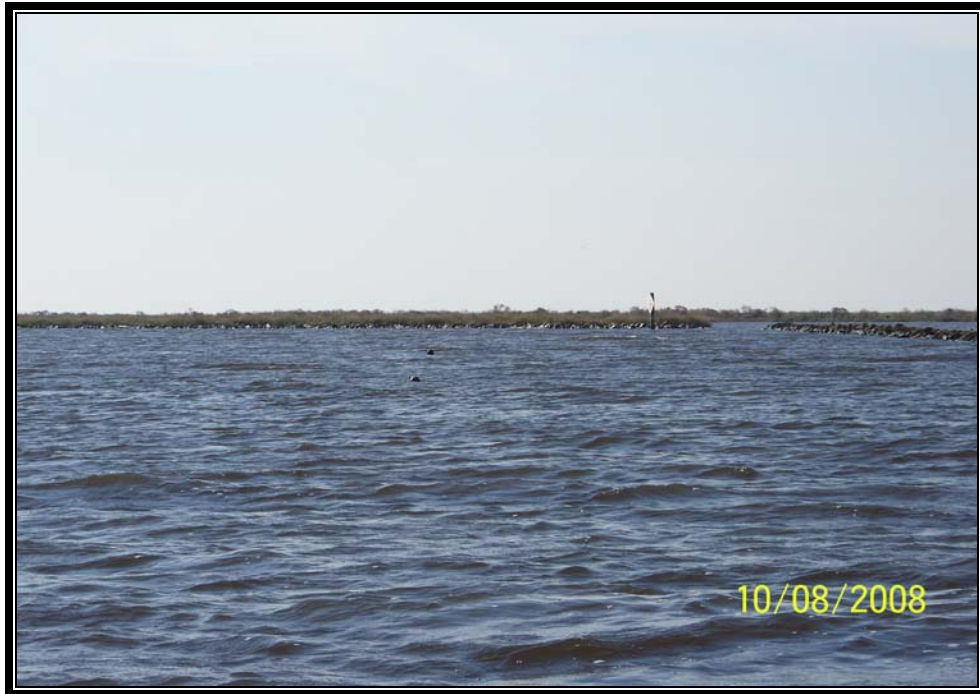
Photo 17 (0691) - Rock Segment 14. Tide Reading ~ 2.5 ft NAVD88

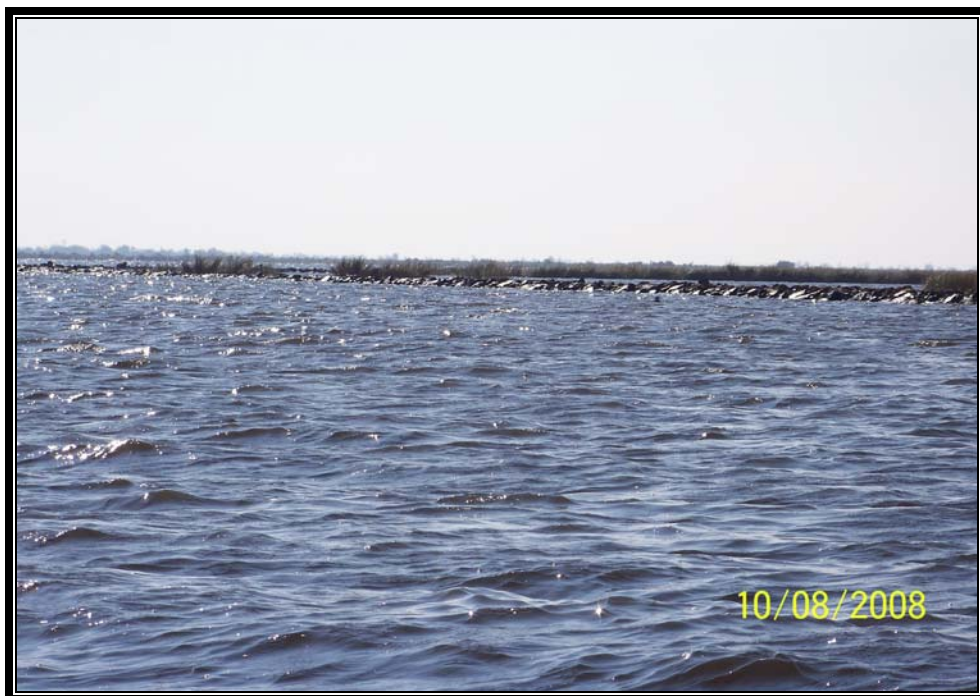
Photo 18 (0692) - Rock Segment 15. Tide Reading ~ 2.5 ft NAVD88

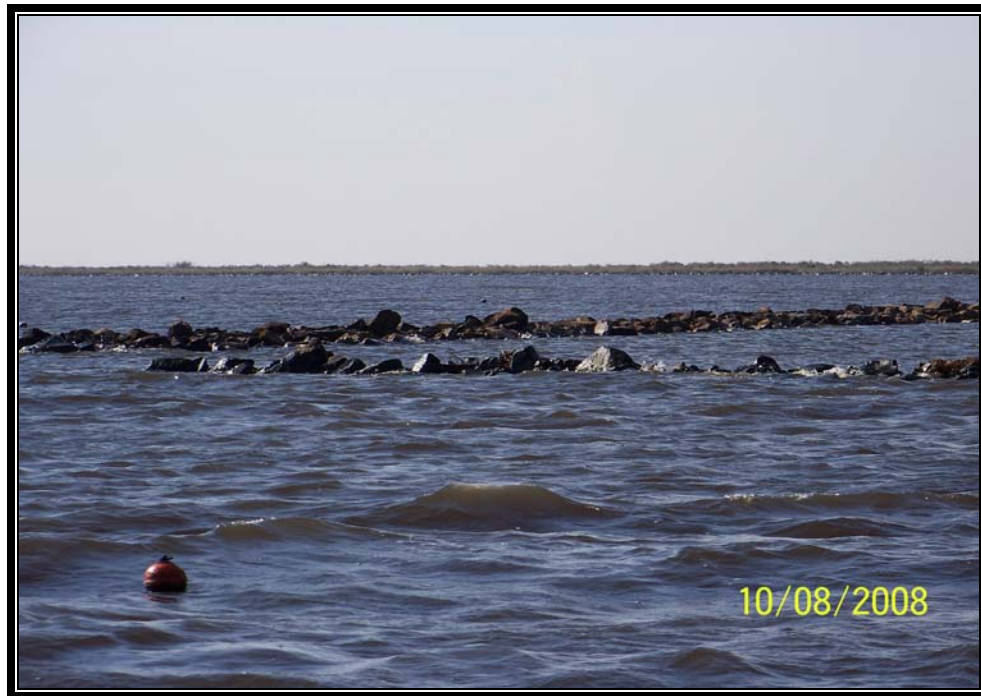
Photo 19 (0693) - Rock Segments 15 and 16. Tide Reading ~ 2.5 ft NAVD88

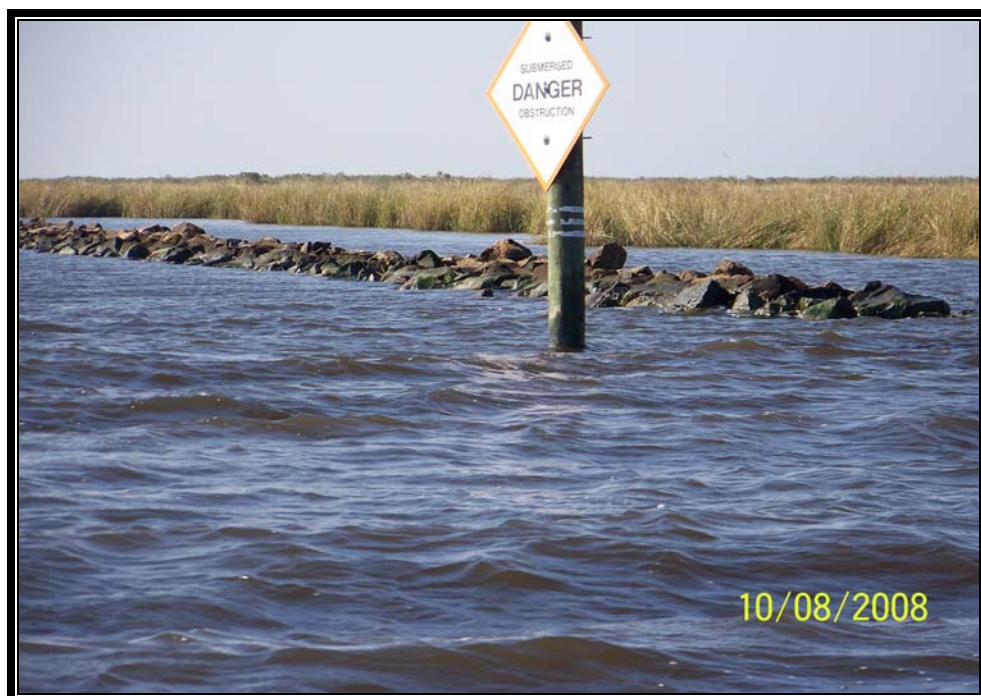
Photo 20 (0694) - Rock Segment 16. Tide Reading ~ 2.5 ft NAVD88

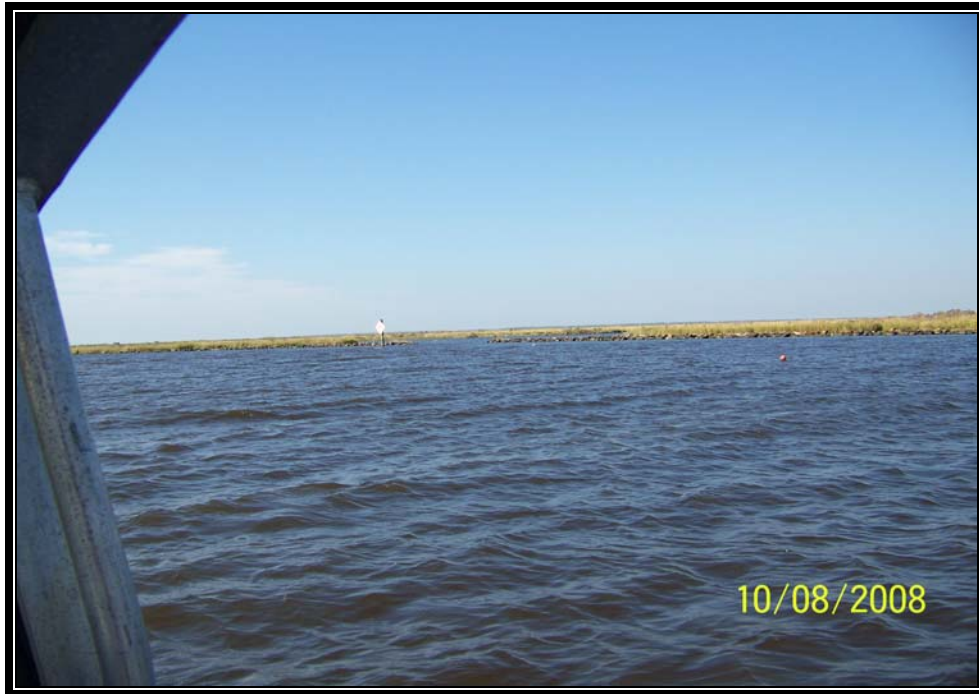
Photo 21 (0695) - Rock Segments 16 and 17. Tide Reading ~ 2.5 ft NAVD88

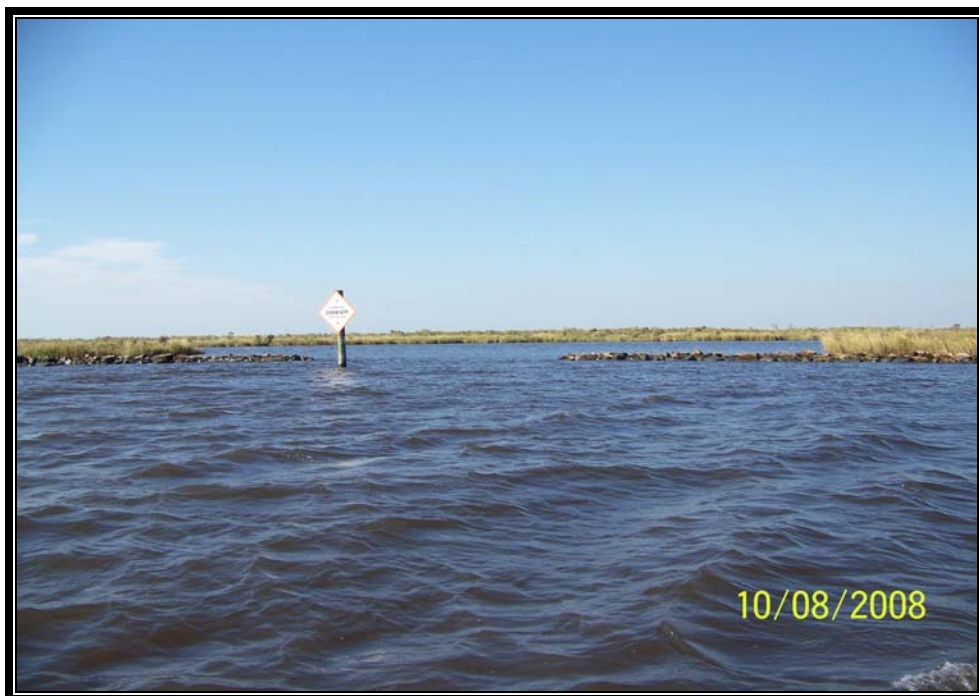
Photo 22 (0696) - Rock Segments 17 and 18. Tide Reading ~ 2.5 ft NAVD88

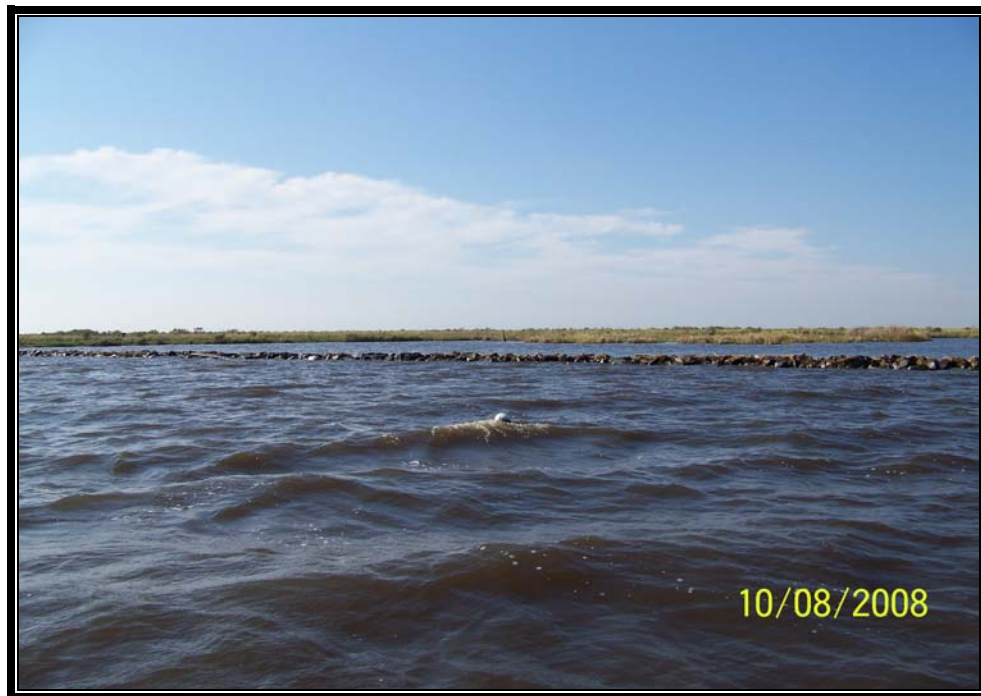
Photo 23 (0697) - Rock Segment 18. Tide Reading ~ 2.5 ft NAVD88

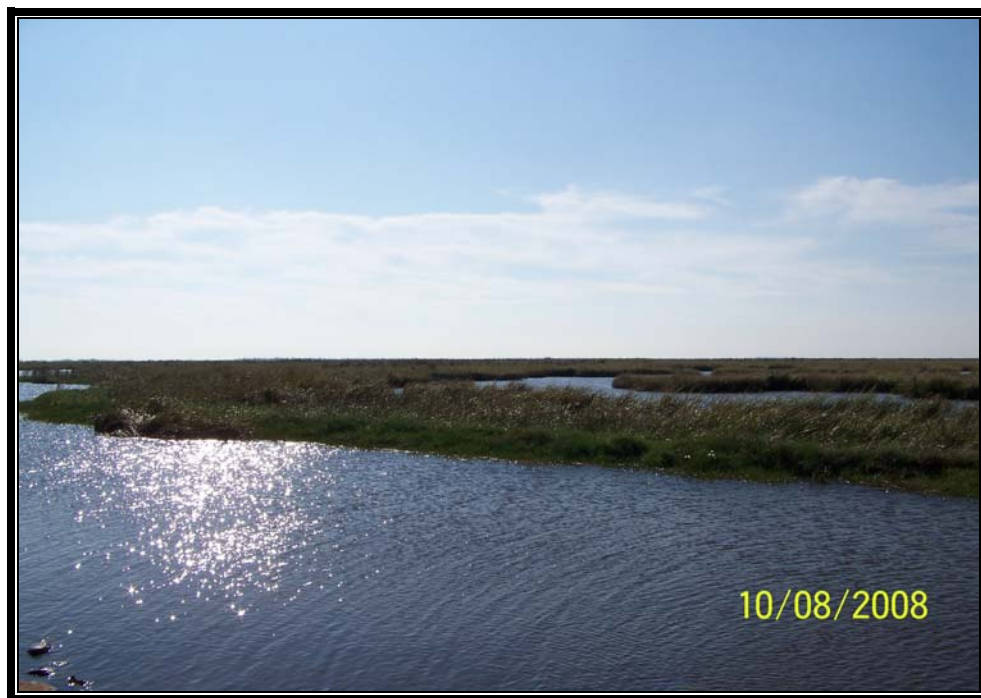
Photo 24 (0699) - Marsh creation behind Rock Segment 19. Tide Reading ~ 2.5 ft NAVD88

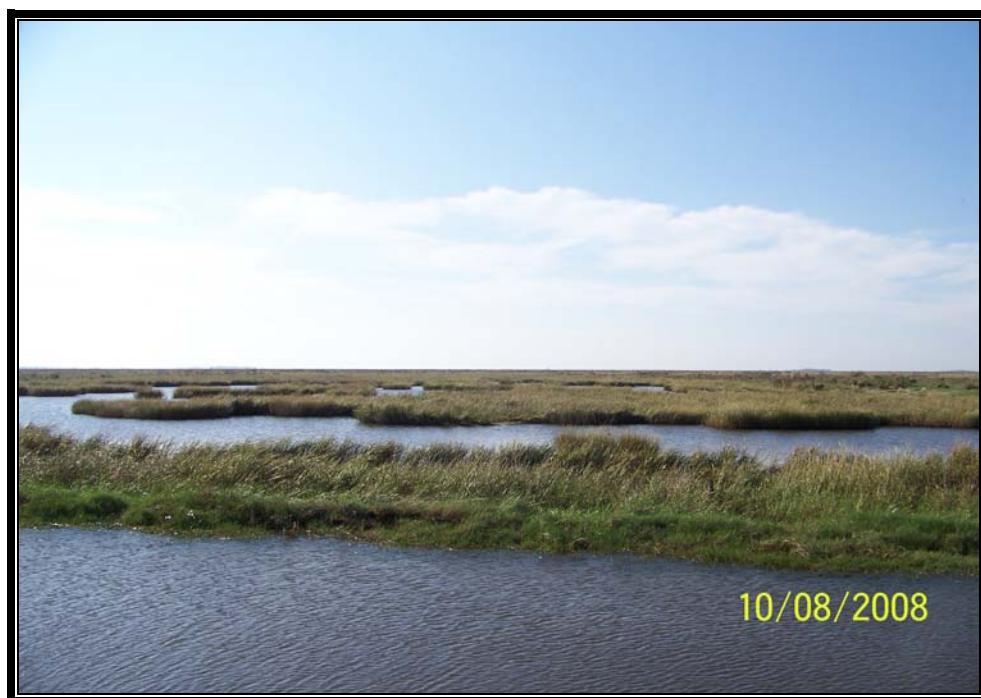
Photo 25 (0700) - Marsh creation behind Rock Segment 19. Tide Reading ~ 2.5 ft NAVD88

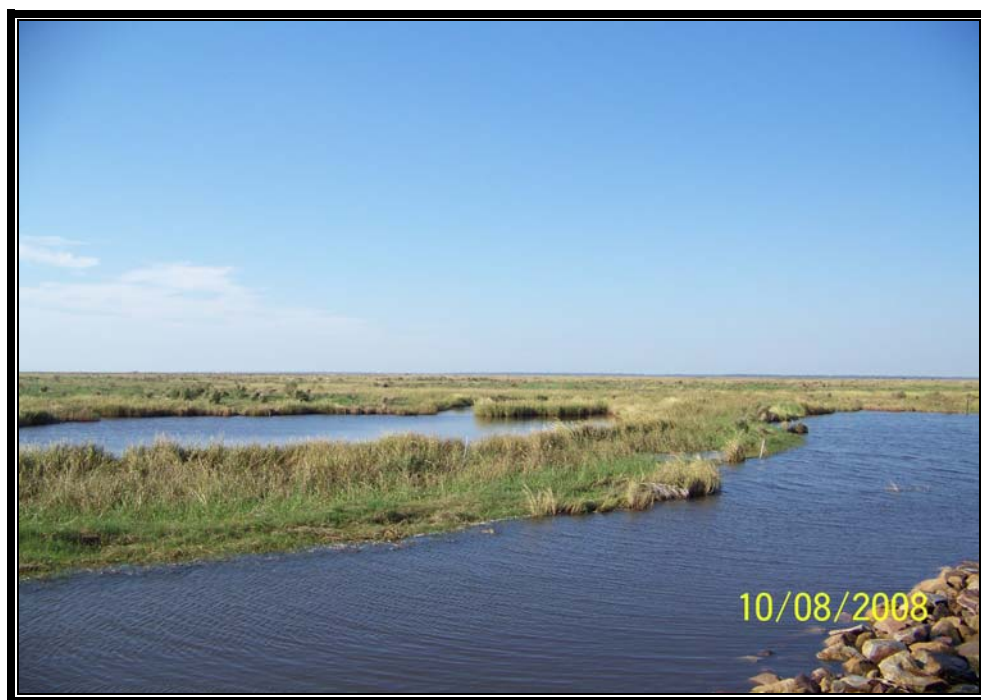
Photo 26 (0701) - Marsh creation behind Rock Segment 19. Tide Reading ~ 2.5 ft NAVD88

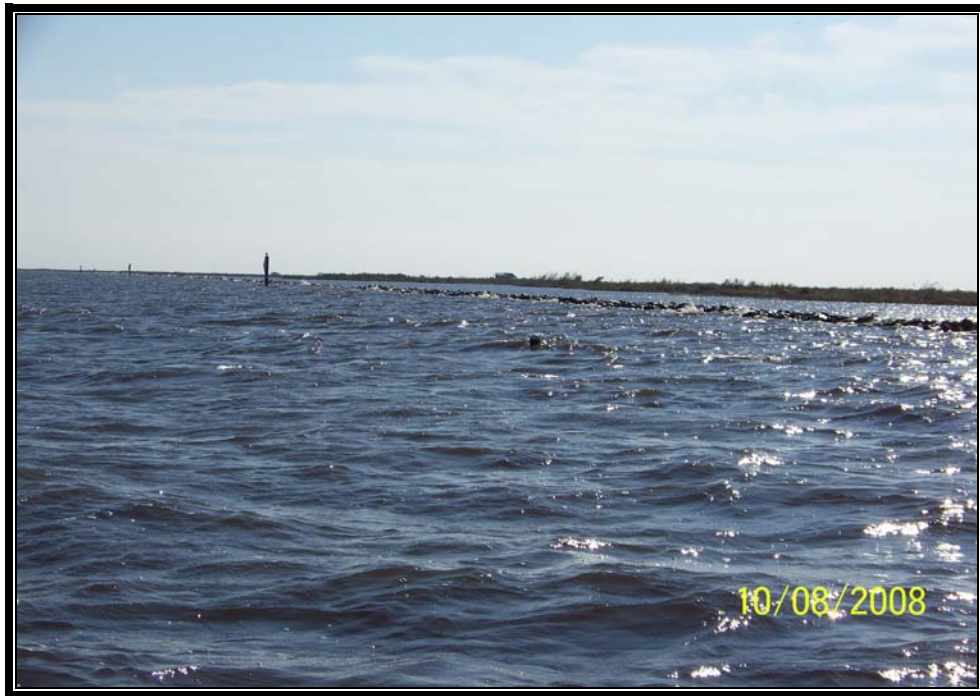
Photo 27 (0702) - Rock Segment 21. Tide Reading ~ 2.5 ft NAVD88

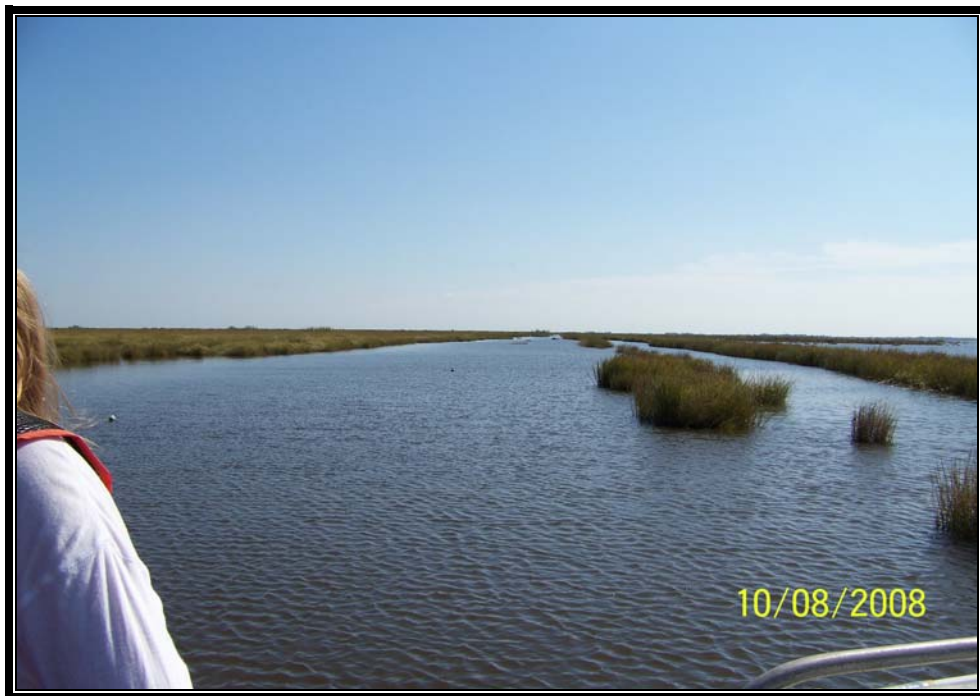
Photo 28 (0705) - Southwest corner of marsh creation area within containment borrow channel looking east. Vegetated, created marsh can be seen left and vegetated dike right.

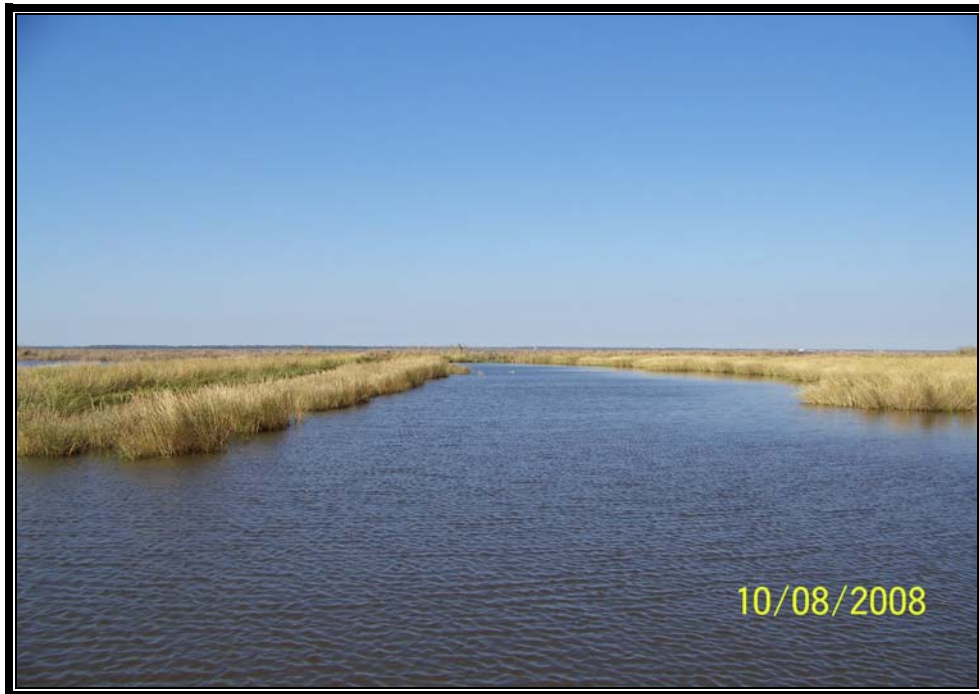
Photo 29 (0706) - Southwest corner of marsh creation area within containment borrow channel looking west. Vegetated, created marsh can be seen right and vegetated dike left.
